Pest Report

22 Clark Drive

BAYSWATER

Report Prepared: 19 May 2015

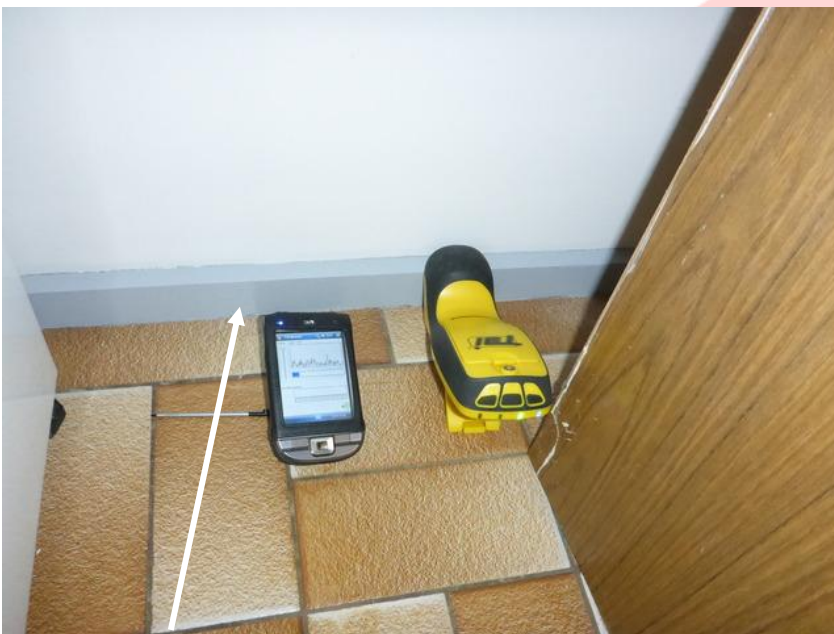
- Visible evidence of subterranean termite workings and/or damage was found at the time of inspection. It was in, but not necessarily limited to the following location(s) - the laundry skirting boards, the hallway cupboard door frame, the hallway skirting boards and under the front door.

Active termites in the laundry skirting boards.

- At the time of the inspection it is recommended that a treatment in accordance with Australian Standard 3660.1 to control or prevent subterranean termites from infesting and causing damage to the property be carried out or have annual termite inspections.

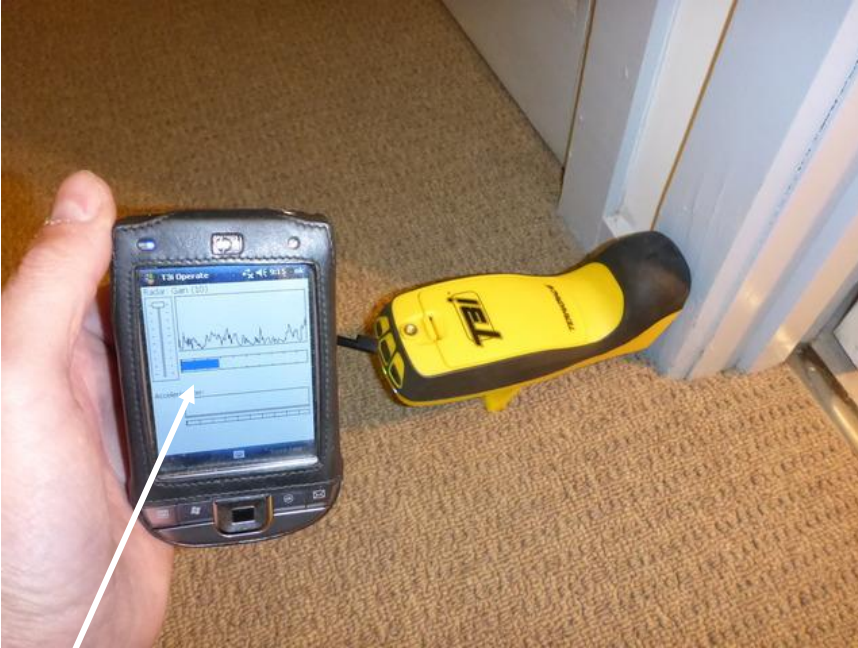
Active termites in the hallway cupboard skirting boards and cupboard door frame.

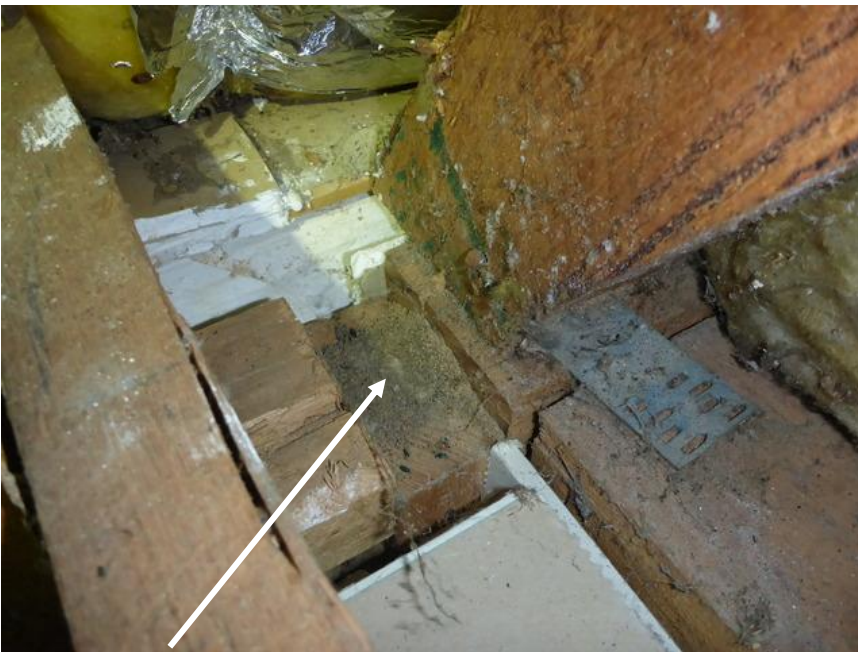
- Evidence of subterranean termite activity or damage was sighted in timber roof joists around the hallway.

Termite mud trail in roof frame.

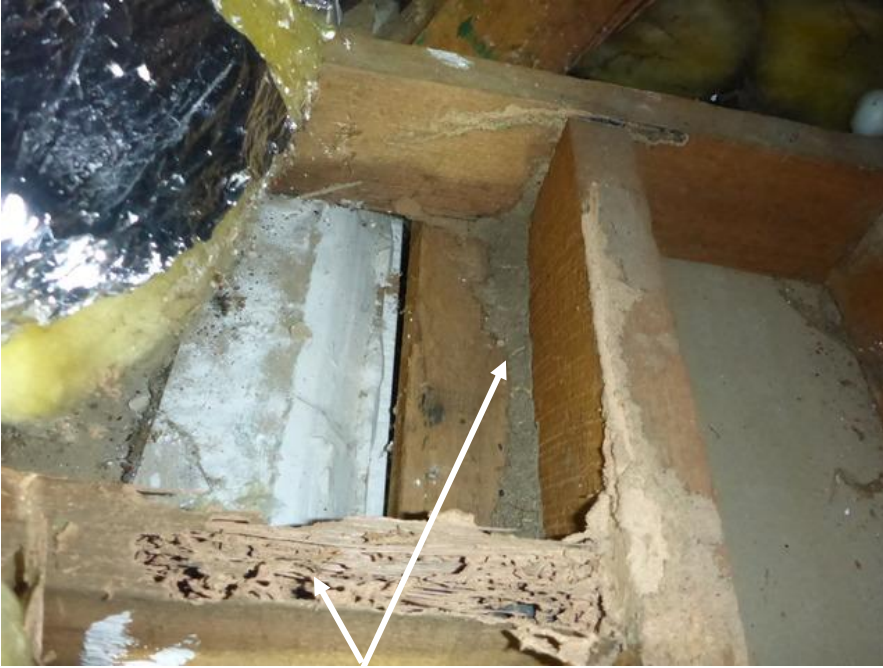
Damaged timber roof frame and termite mud trail in roof

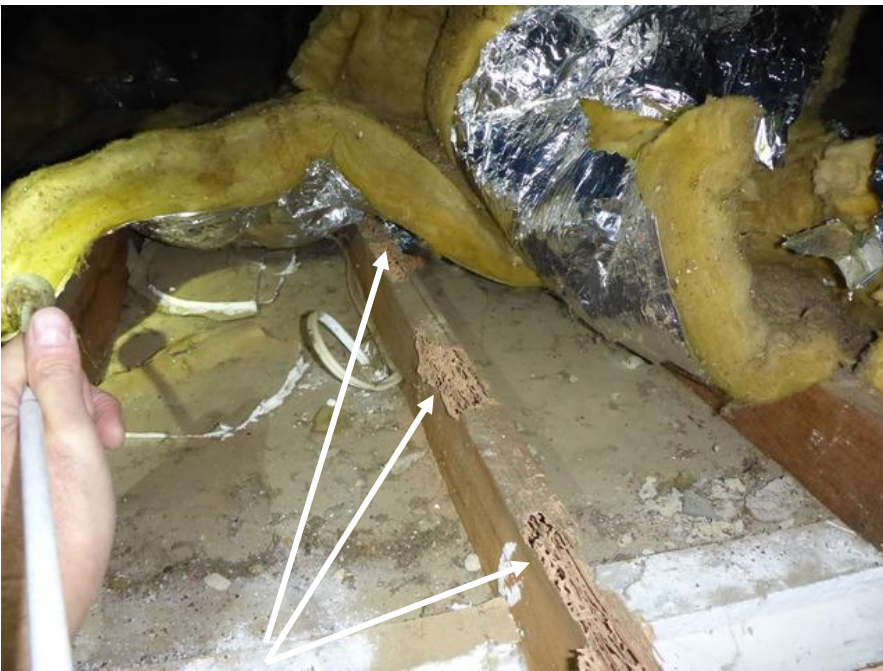
Termite damaged ceiling timbers.

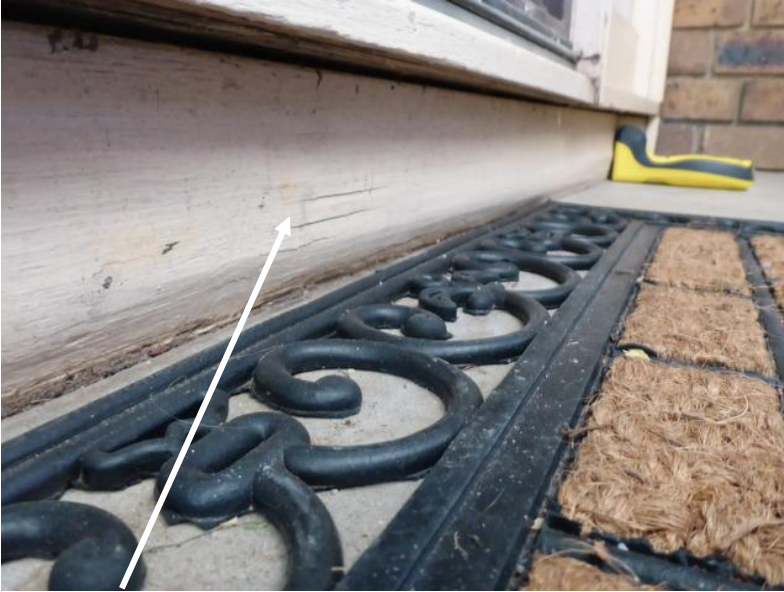
Past termite damage in the timbers under the entrance door.

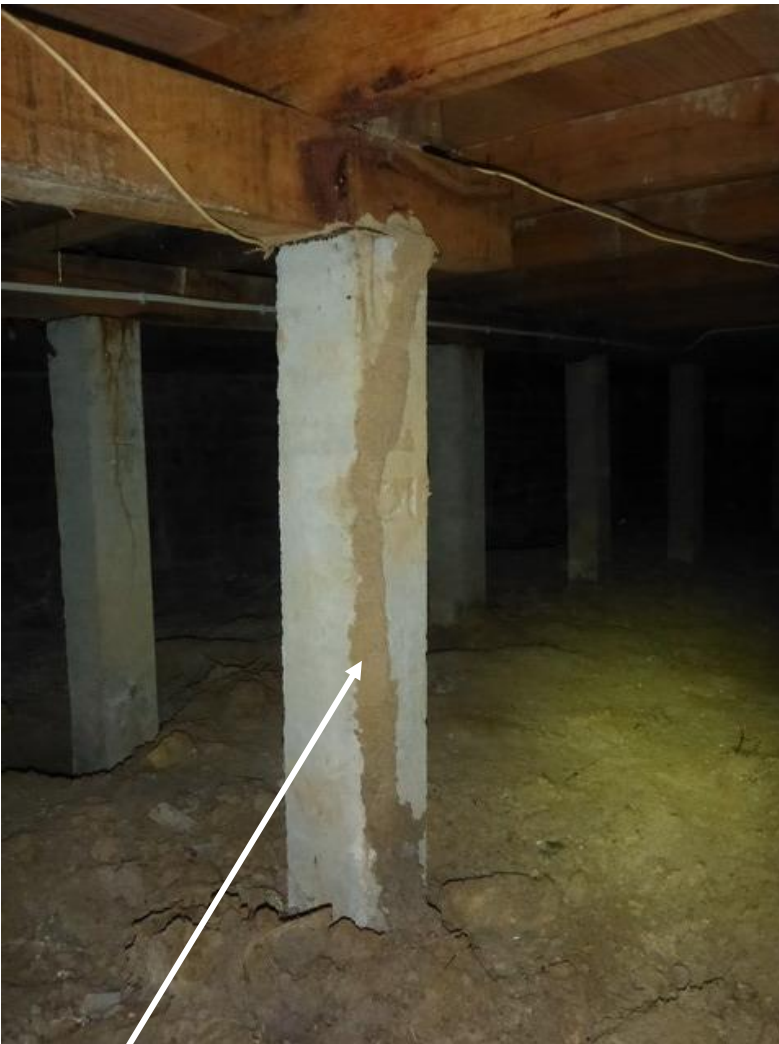
1st active termite trail near the entrance.

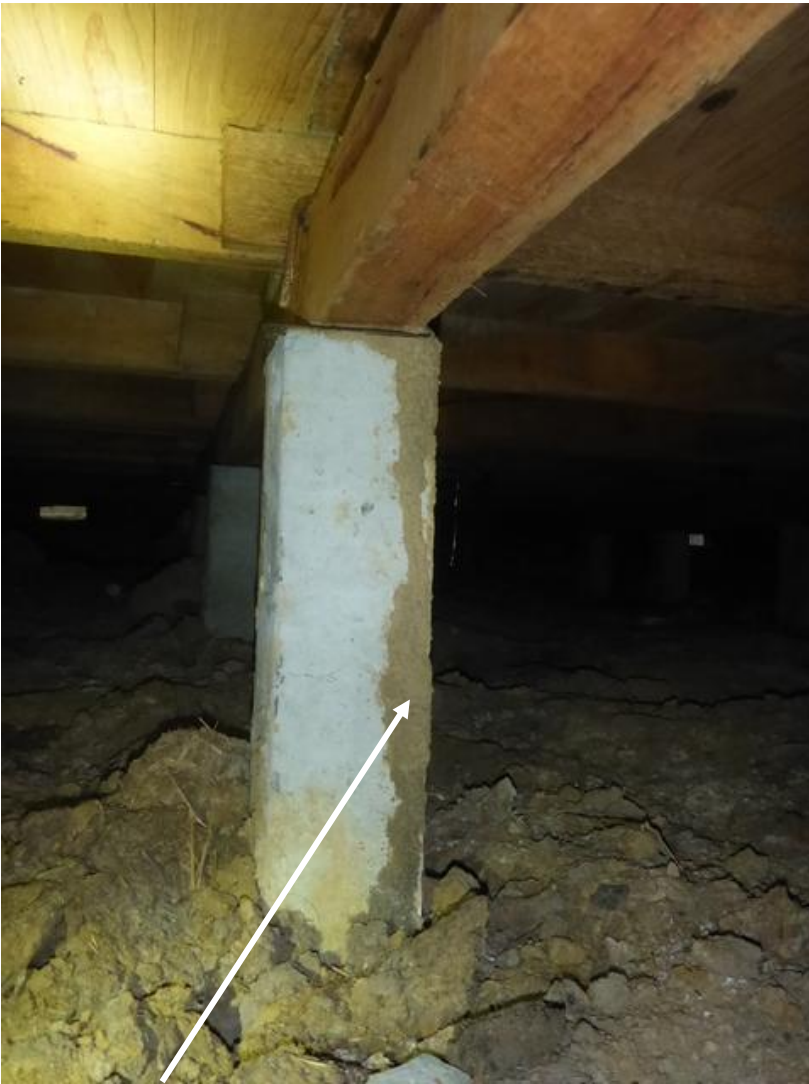
2nd active termite mud trail at the end of the hallway.

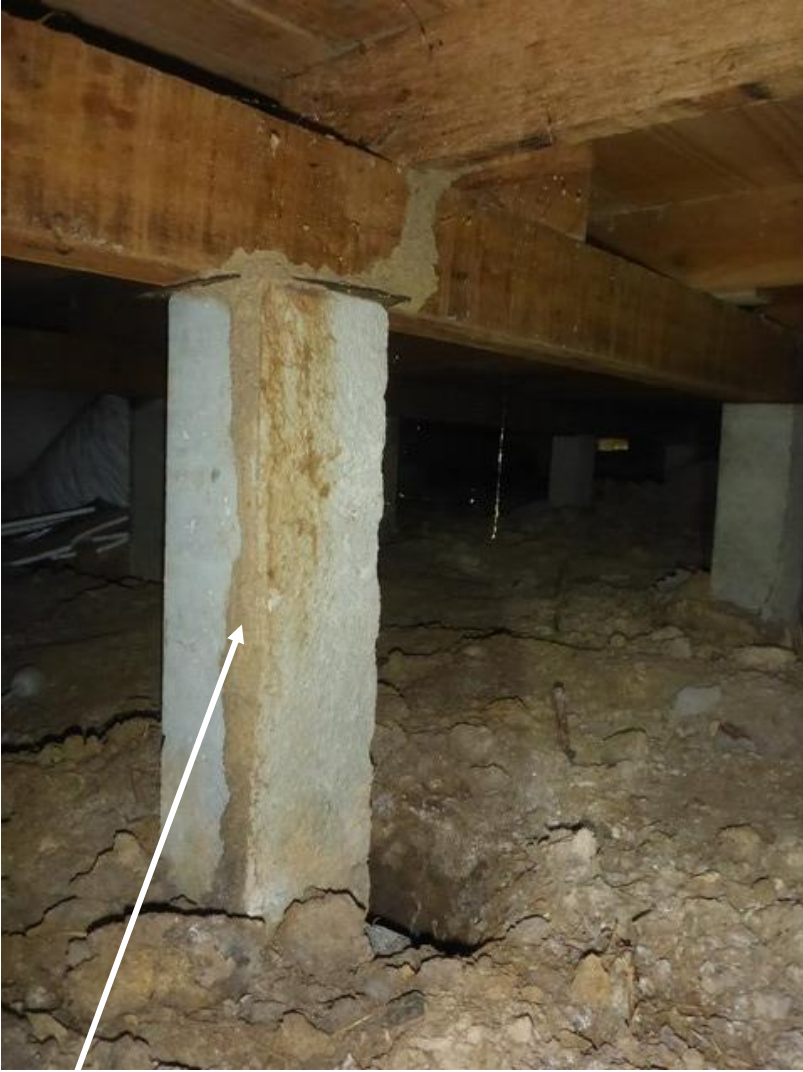
3rd active termite trail at the end of the hallway.

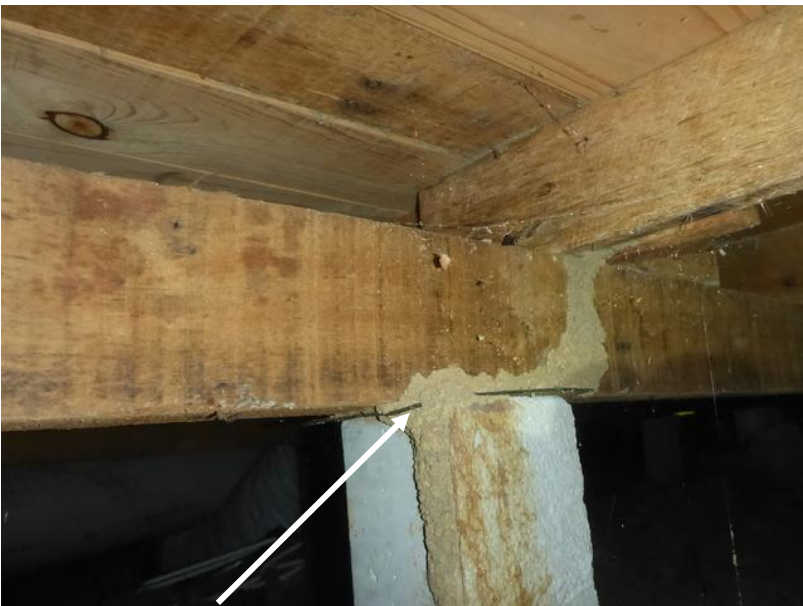
These are substantial mud trails therefore termites have been active for some time.

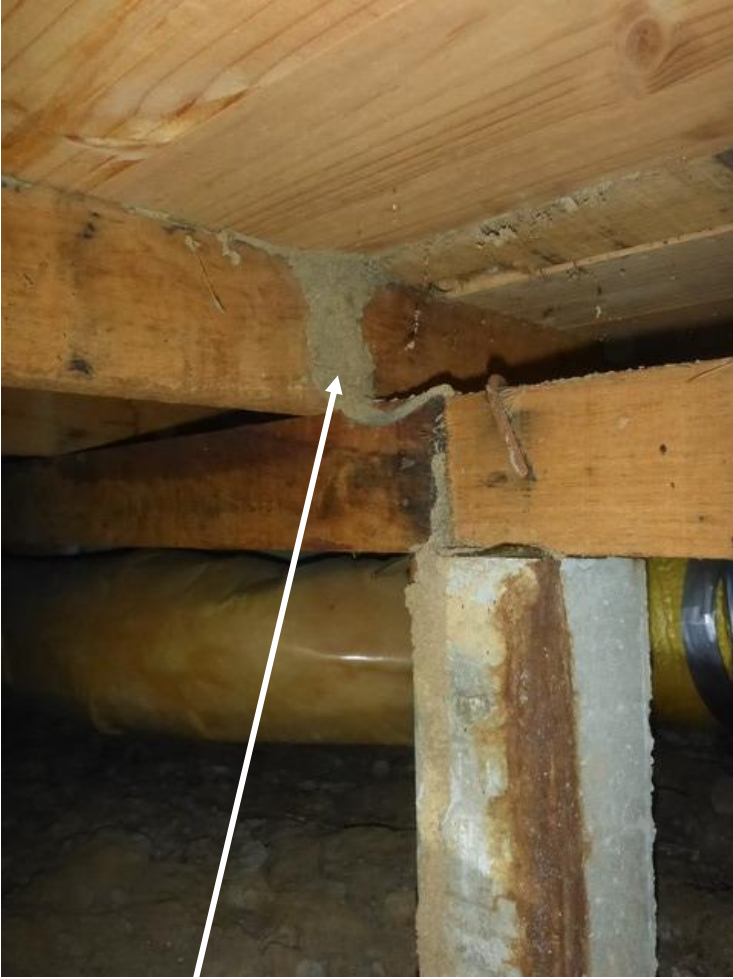
Termites mud trail access to the wall structure.
